Safety Inspection Report

Annual Inspection

Coaley Play Area

18 April 2024

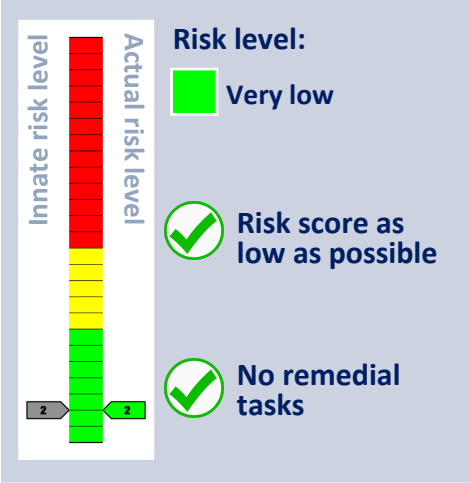
Signage

Innate risk level
Actual risk level
2
2
Risk level:
Very low
Risk score as low as possible
No remedial tasks

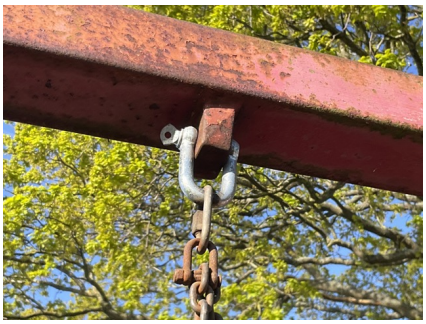
Swing shackles or associated components are seized.

Free off and check for damage.

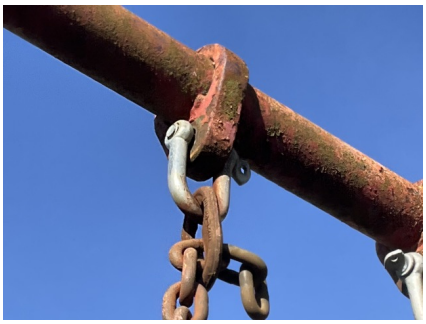
There is wear in the bushes.

Remove shackle bolt and check bush and shackle pin wear, replacing as necessary.
